Bentofix[®] X, Secutex[®]

Base Lining System in Dam

- **Project Name**
Dam Rehabilitation (Mamak & Pernek), Indonesia
- **Year constructed**
2022 - 2023
- **Supplier & installer**
PT. Indramas Enviro Karya - Tangerang, Indonesia
- **Consultant**
PT. Raya Konsult – Bandung, Indonesia
- **Product**
Bentofix[®] X2 NSP 4900
Secutex[®] MR 1201

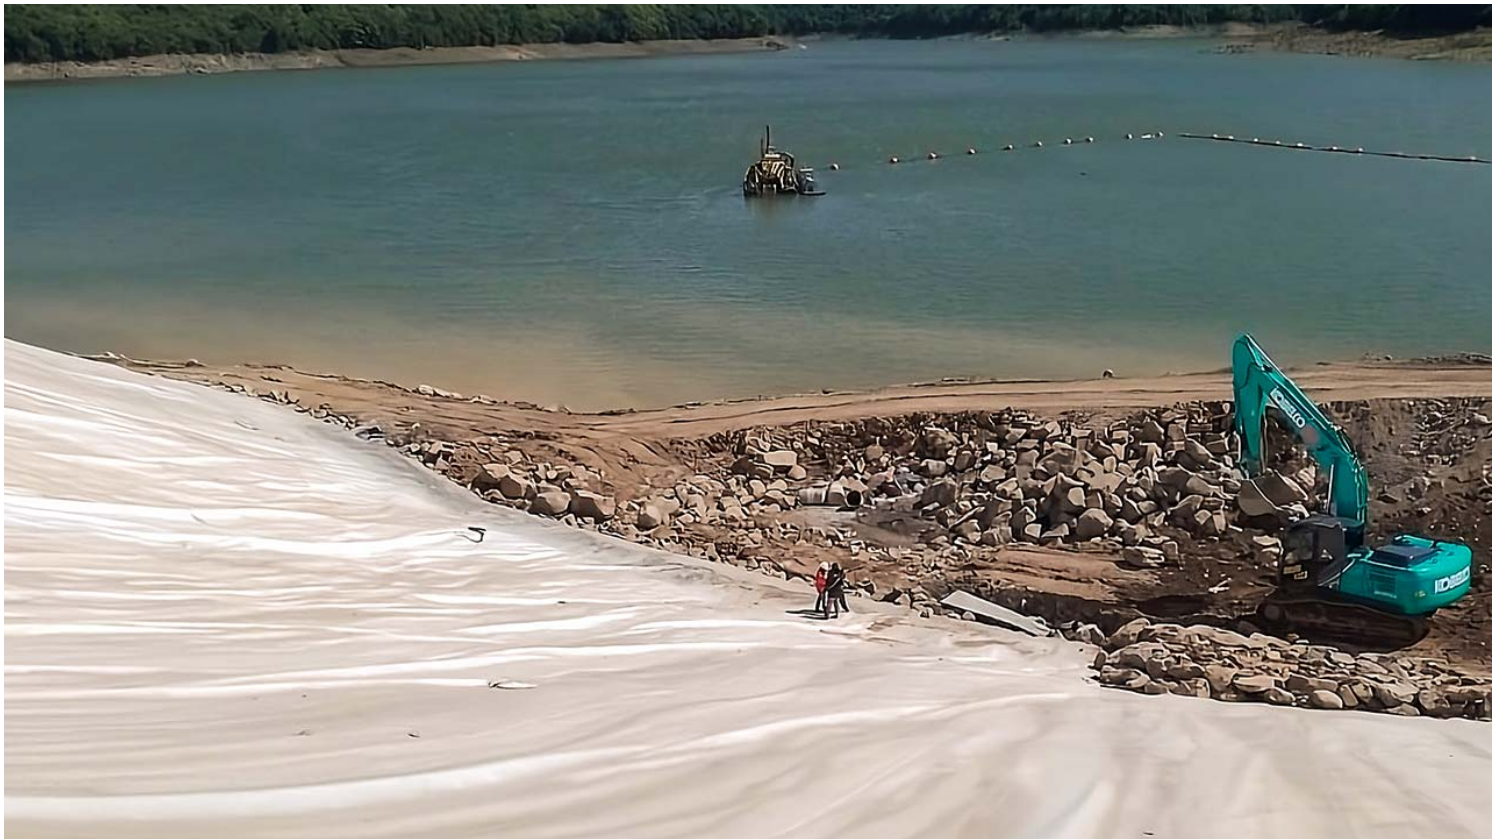
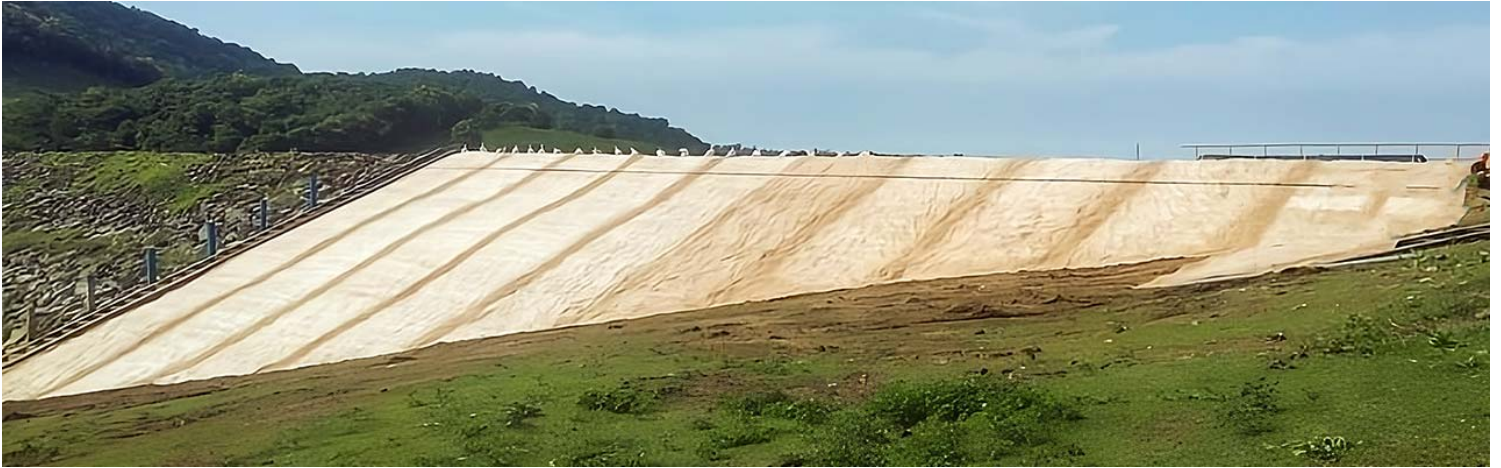
Naue worked together with the consultant, PT. Raya Konsult, and our partner, PT. Indramas Enviro Karya, to propose a multicomponent geosynthetic clay liner (GCL) Bentofix® X as part of a composite lining system with 2mm HDPE as a sealing element at the side slope of the dam embankment. The characteristic of Naue Bentofix® GCL allows rapid installation and a unique, self-healing PE-coated GCL to prevent water seepage from entering the embankment body should the primary liner fail. On top of the Bentofix® X multicomponent GCL and 2mm HDPE geomembrane, a nonwoven geotextile Naue Secutex® is installed to act as a protection layer against deformation of the lining system by coarse soil particles.

The state-of-the-art design of the HDPE geomembrane and Bentofix® X GCL as the lining system provides a groundbreaking solution to rehabilitate the earth-fill dam. The method reduces costs and environmental impact of the works whilst offering a fully supervised quality of manufacturing and installation of lining system components. It also allows the transfer of a similar design into new earth-fill dam construction. Using geosynthetics in these projects led to faster and easier construction than traditional methods while at the same time reducing emissions and traffic, contributing towards a more effective and sustainable practice in dam remediation projects.
