# Secugrid® HS - Reconstruction of Oder dyke in Uckermark county

## Basal reinforced embankments

- **Project Name**  
Reconstruction of Oder dyke in Uckermark county, Polder 5/6, Part 15, Lot 67
- **Engineer**  
Ingenieurgemeinschaft WTU GmbH, Bad Liebenwerda
- **Installation contractor**  
Streicher Tief- und Ingenieurbau Jena GmbH & Co. KG, Jena
- **Product**  
Secugrid® HS 1000/100 R6

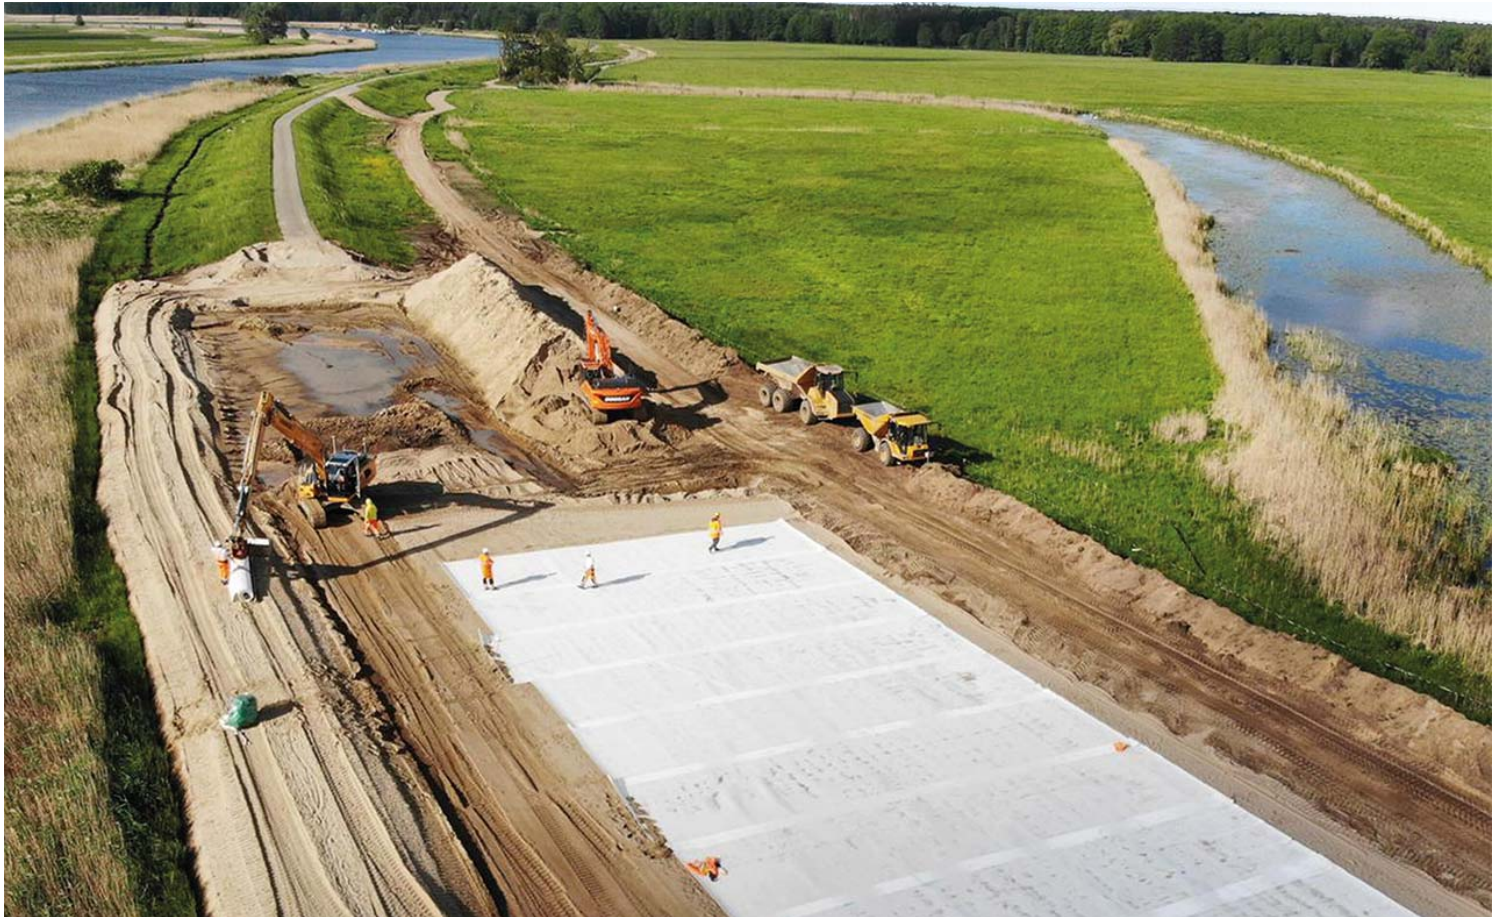
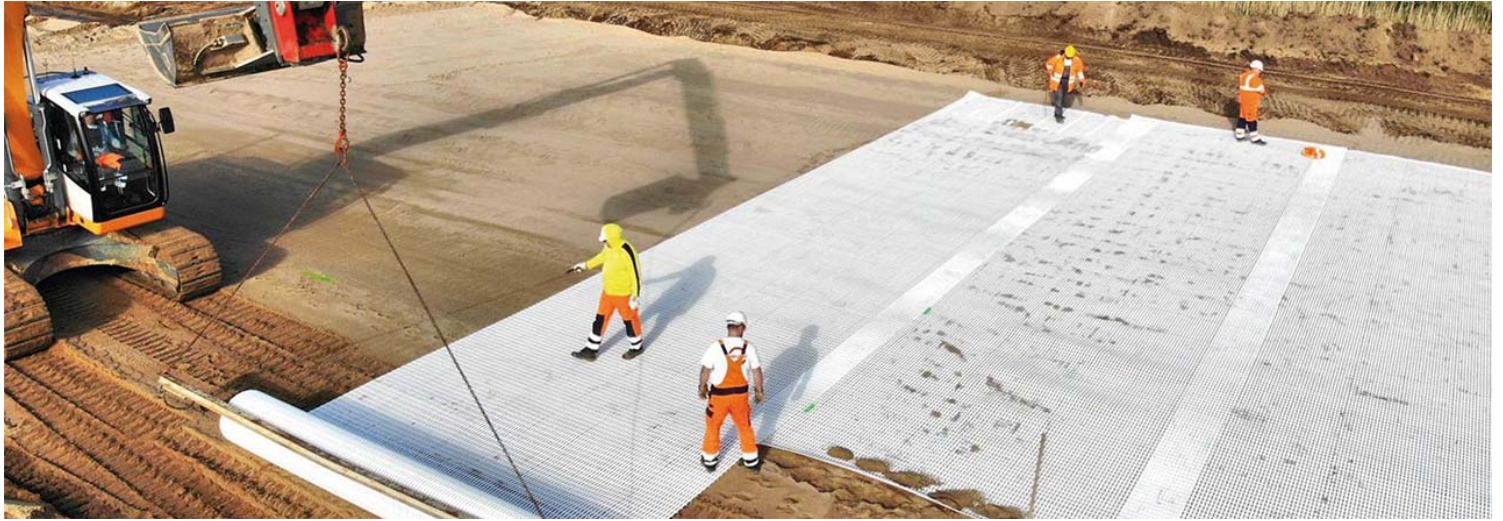
In order to withstand future flood events, an existing dyke was reconstructed over a length of 3km between the municipality of Friedrichsthal and the city of Gartz. Soil investigations below the old dyke revealed relatively deep soft layers of peat, organic silt and clay. In order to ensure sufficient stability of the new dyke, the geogrid Secugrid® HS was installed as basal reinforcement. The individual geogrid panels were installed with their main stress direction perpendicular to the dyke axis by using a spreader bar. Adjacent panels were overlapped by 50cm transverse to the direction of installation. Over the entire length of the dyke between Friedrichsthal and Gartz, a total of approx. 63,000 m<sup>2</sup> of the high-strength geogrid was installed.

The reconstruction of the dyke was carried out by partial removal of the old dyke and a reconstruction as a so called "3-zone dyke". On the slope, facing the water-side, a geosynthetic clay liner (GCL) was installed as sealing system.
