# Secugrid® - Repair of flood damage „Leubethaer Street“ in Freiberg - Germany

## Roadway Embankment Reconstruction

- **Project Name**  
Repair of flood damage „Leubethaer Street“ in Freiberg, Germany
- **Designer**  
Ökoplan Bauplanung GmbH, Plauen, Germany
- **General contractor**  
UTR Umwelt-, Tiefbau und Recycling GmbH, Schönbrunn/Vogtland, Germany
- **Subcontractor GRS**  
GGG TerraCon GmbH, Moritzburg, Germany
- **Product**  
Secugrid® 80/20 R6  
Secugrid® 40/20 R6  
Secumat® ES 401 G4

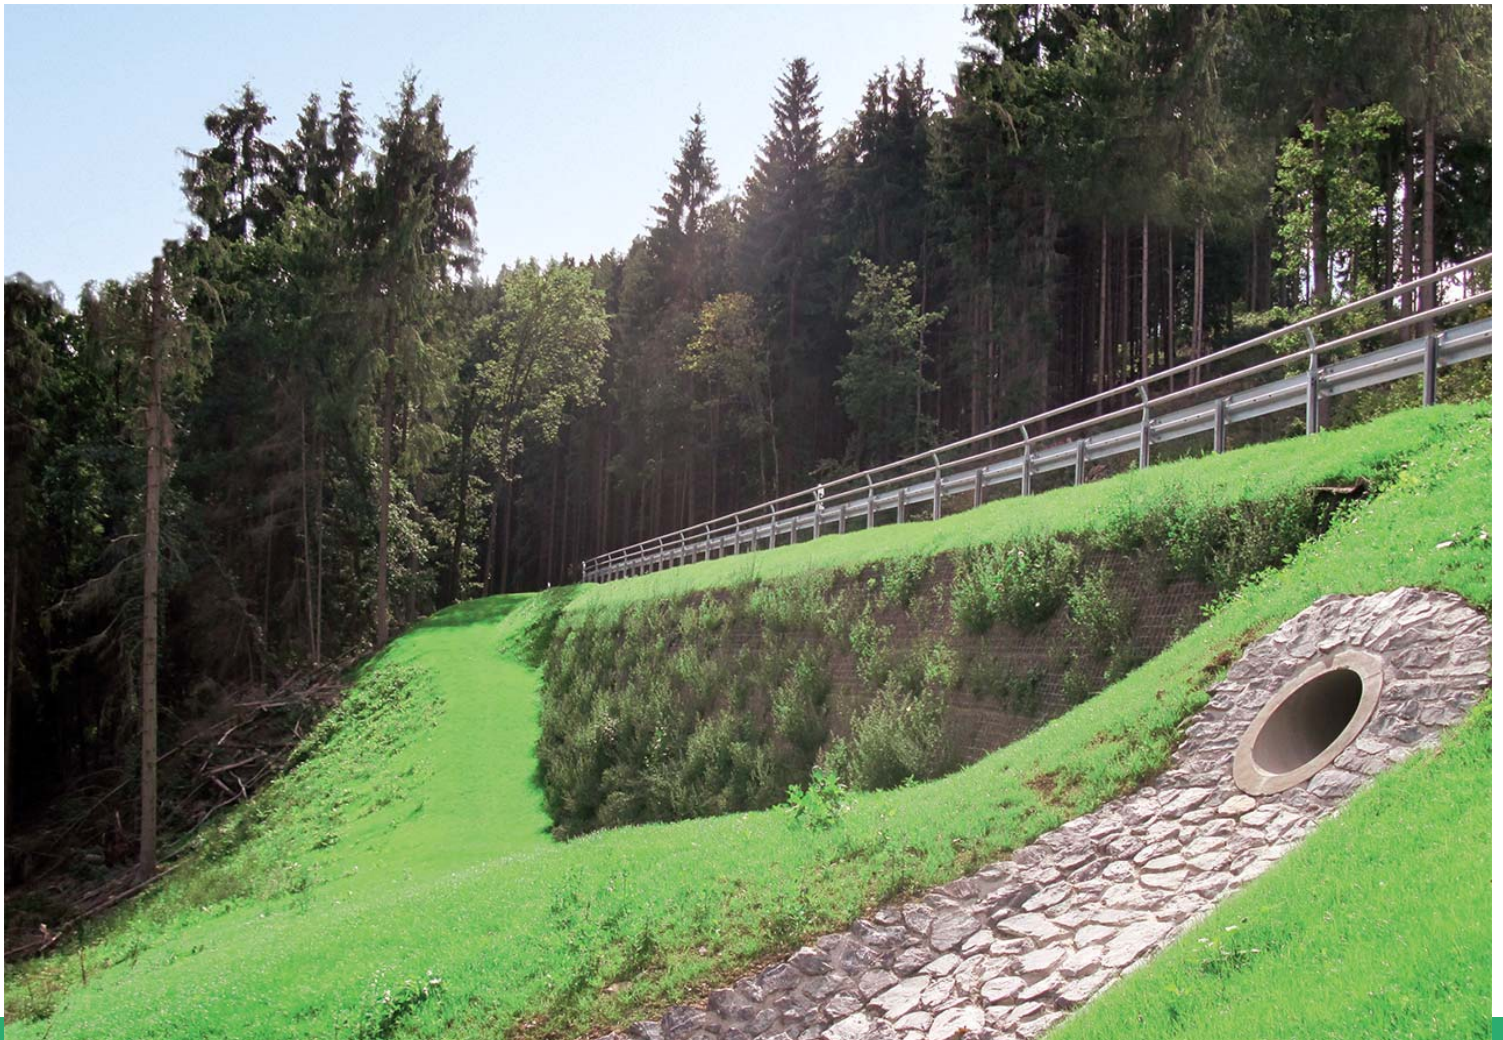
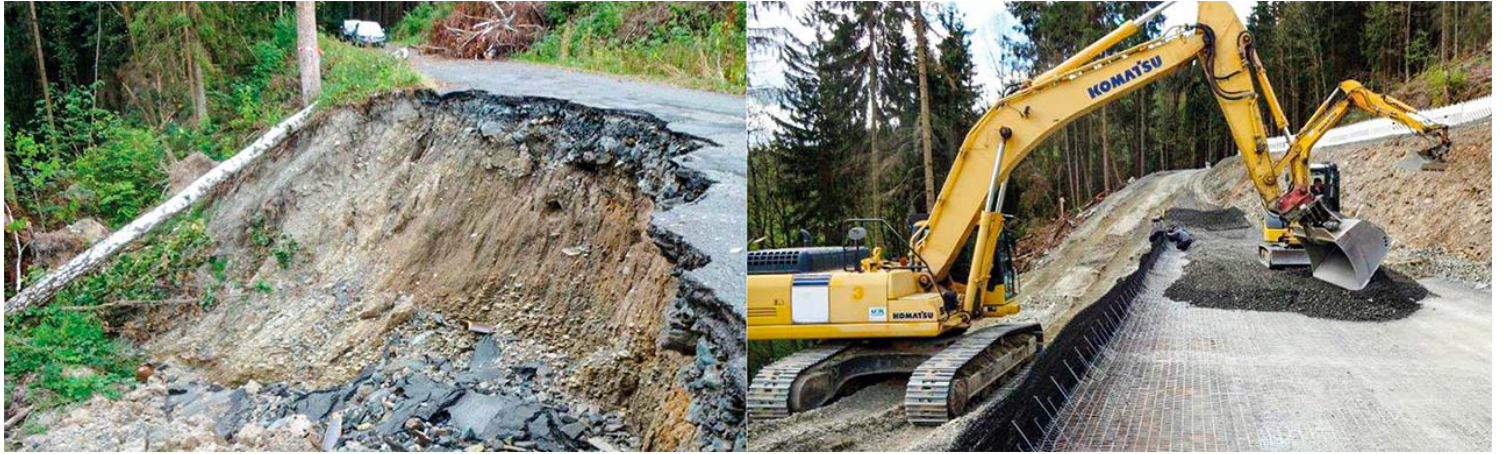
With financial support from the Federal State of Saxony, the failed slope was rehabilitated. The reconstruction of the embankment was carried out as geogrid-reinforced soil structure (GRS) with Secugrid® geogrids from Naue. Over a length of approx. 54m the road embankment was rebuilt with a slope inclination of 70°.

The Naue Steel P system was used for the design of the facing. This system consists of galvanized steel mesh units, which can be adapted to the planned contour of the slope. By overlapping the horizontal part of the steel mesh with the uniaxial Secugrid® geogrid a frictional connection is achieved. A total of 11 geogrid layers were installed for the maximum embankment height of 7.7m. The individual geogrids were each covered with 50cm of fill soil and then compacted in layers.

To prevent soil erosion at the slope face, a Secumat® erosion control mat was installed between the steel mesh and the filling soil. The subsequent greening of the embankment surface ensures that the GRS integrates perfectly into the existing landscape. With the GRS solution chosen in this project, an economical and ecological rehabilitation has been achieved which will safely withstand future flood events.
